# Evaluation of Potential Use of Vegetation for Erosion Abatement Along the Great Lakes Shoreline

MISCELLANEOUS PAPER NO. 7-75  
JUNE 1975

Prepared for  
U.S. ARMY, CORPS OF ENGINEERS  
COASTAL ENGINEERING  
RESEARCH CENTER

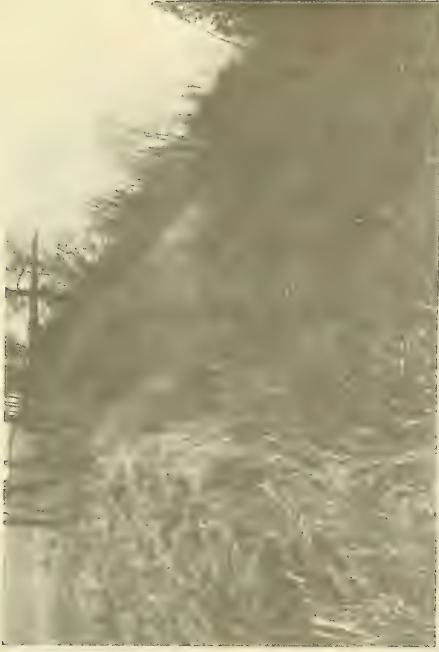
Figure 6. Lake Michigan bank erosion caused by seepage through sand and gravel layers in the glacial till (left). Dewatering, bank reshaping, and seeding to prevent erosion by runoff has stabilized bank recession (above). (Courtesy of Soil Conservation Service.)

The Soil Conservation Service at Kewaunee, Wisconsin, has successfully stabilized shores by dewatering the glacial till, sloping the face of the bluffs, and seeding the reshaped slopes (Fig. 6). In this case, dewatering is the key factor and is essential to control erosion caused by seepage.

Land alteration has proved essential for controlling shore and bank erosion in many areas of the Great Lakes. Near Kewaunee, Wisconsin, for example, seepage contributes to bank failure along Lake Michigan. The Soil Conservation Service has successfully installed a deep tile line to intercept seepage and conduct the underground water to Lake Michigan. The banks were reshaped to an approximate slope of 2:1 and the soil was seeded with a mixture of crown vetch and fescue to control surface runoff. Similar dewatering has been effective in urban and rural areas. The work is costly, especially on high banks. In time, if seeding has successfully stabilized soil on the banks, native plant species invade and become established along with planted species.

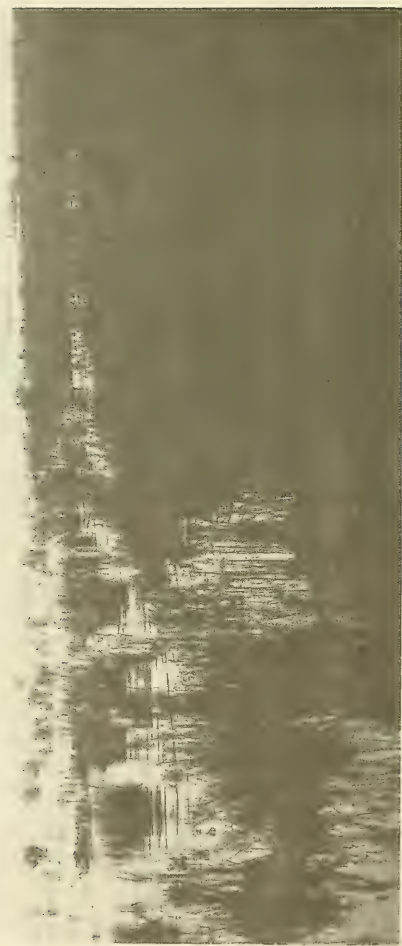
Figure Gently sloping shoreline (Lake Michigan) and relatively quiet waters provide a suitable habitat for bluejoint, great bulrush, and rush.

A gently sloping shore 3.5 miles east of State Route 134 and the Interstate 75 interchange provided suitable habitat for bluejoint, great bulrush, and rush (Fig. 8). Although bluejoint and rush are flood-tolerant, they are not important species for wave attenuation.

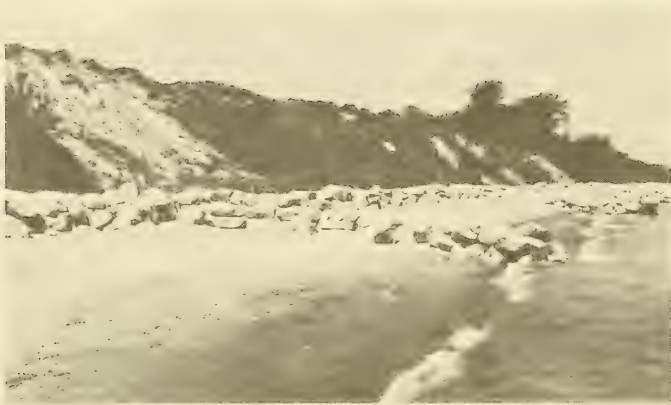
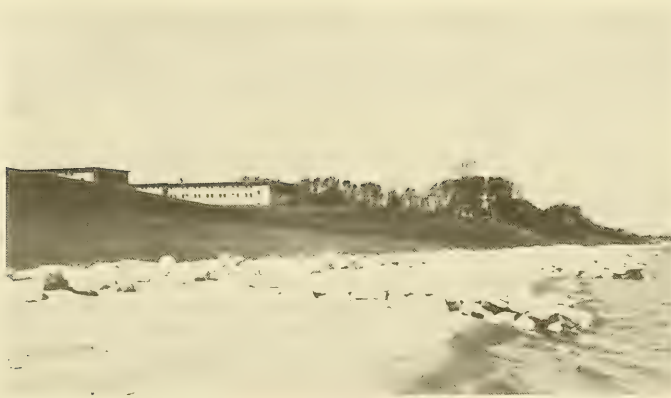
Figure 11. Reformation of rough bank (above) and landscaping of shoreline (below).  
(Courtesy of Soil Conservation Service.)

An example of a Lake Michigan shore modification is shown in Figure 11. The site was in Racine County about 3 miles north of Racine, Wisconsin. Rock was used for shoreline protection to minimize erosion of the embankment. The rough steep bank was graded to a more gentle slope and was seeded to control surface erosion. This shore front modification requires a soil that is not subject to seepage so severe that it causes bank failure. Loam soil is best for this type of reclamation. The best vegetative growth is obtained by topdressing with fertilizer and irrigating. Where a specific type of vegetation is desired, weed control may also be required. This shore front renovation requires constant management to maintain a turf appearance.
